DRAFT
**Phase I Environmental Site
Assessment**

Former Armory Building
1249 Main Street
St. Johnsbury, VT 05819

Report Date: January 20, 2022
ASTM Expiry Date: May 15, 2022

Project No.: 185751424

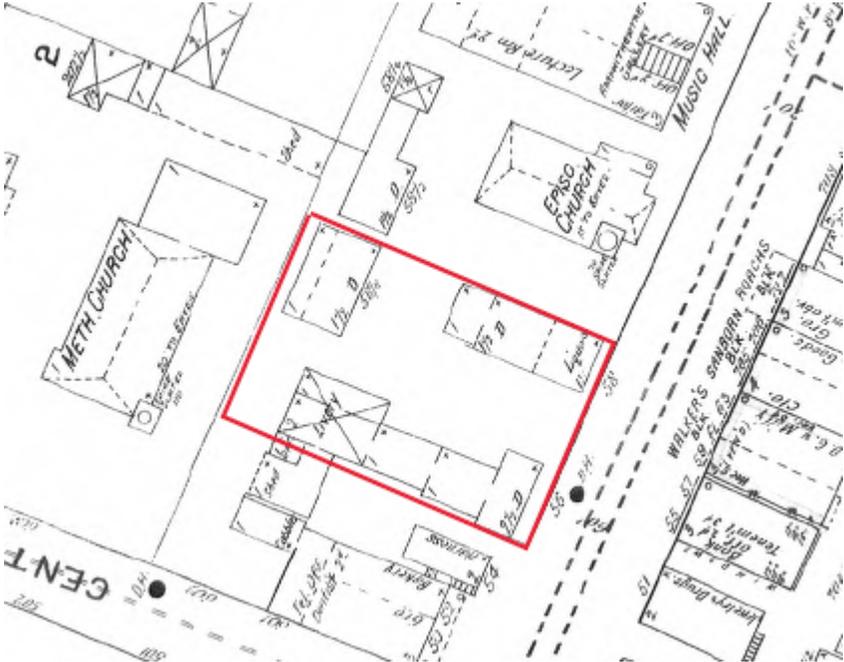
<p>1895 map</p>

Year	Key Observations
1884–1900	<p><u>Property</u>: The Property is developed with three structures: a dwelling in the northeast corner, a building occupied by a dwelling, tailor, and/or meat and liquor store in the southeast corner, and another dwelling with a livery stable in the southwest corner.</p> <p><u>Adjoining Sites</u>: No land uses of environmental significance.</p>

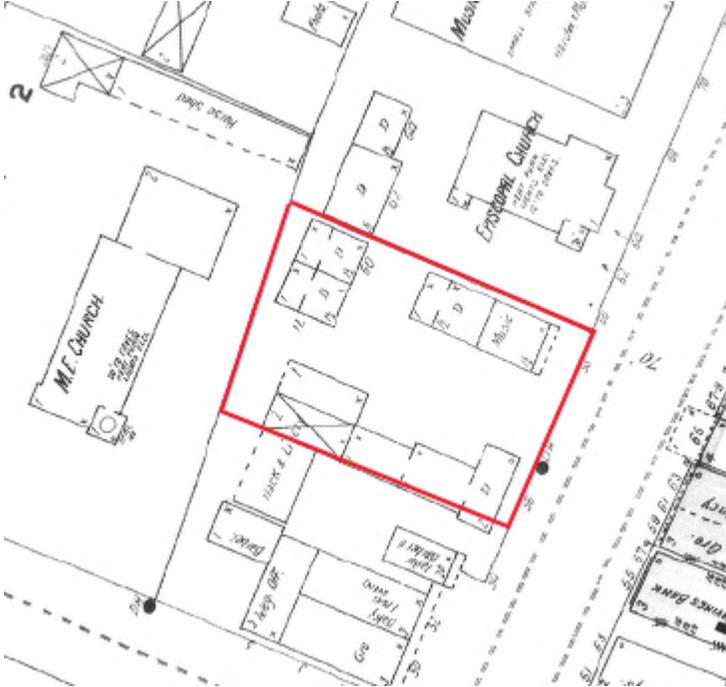
1905 -1912	<p><u>Property</u>: The dwelling in the northeast corner was split into two dwellings and the liquor store in the southeast corner was replaced with a music store.</p> <p><u>Adjoining Sites</u>: No land uses of environmental significance.</p>

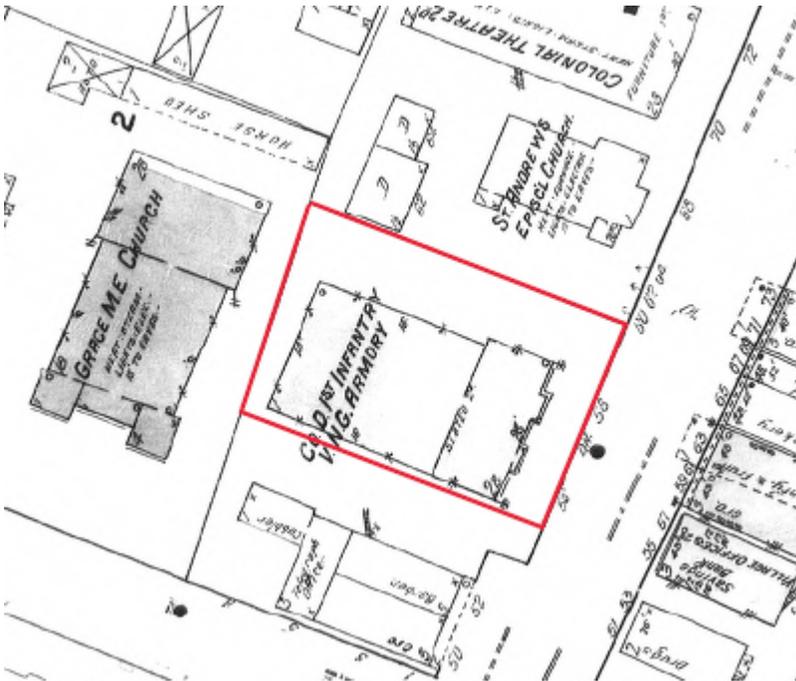
1919–1964	<p><u>Property</u>: The structures on the Property have been replaced with the current building, labeled as Company D 1st Infantry Vermont National Guard Armory with steam heating and electric lights. Per the UST database listing for the Property discussed in Section 4.2.1, the heating fuel for the building was converted from steam to oil in 1971.</p> <p><u>Adjoining Sites</u>: A total of 5 USTs located in upgradient areas from the Property were noted on Sanborn maps from 1943-1964. These tanks are discussed further in Section 4.2.2. A previously indicated three of the five identified tanks associated with the Goss LUST release are considered to be an HREC in connection with the Property, while the other two tanks along Central Street are considered to be a REC in connection with the Property.</p> <p>Two additional tanks were identified at the end of Turner Court about 300 feet south (sidegradient) of the Property on the 1943-1964 Sanborn maps. Additional tanks were identified near the Community Canning Center about 450 feet southwest (sidegradient) of the Property on the 1943 Sanborn map and about 150 feet east (downgradient) of the Property on the 1943 and 1958 Sanborn maps. Being sidegradient or downgradient of the Property, these tanks do not appear to represent RECs in connection with the Property.</p>
