106 Associates  
11 Ward Street  
Burlington, VT 05401  
(802) 777-1572  
scottnewman@106associates.com

December 23, 2021

Re: St. Johnsbury Armory Redevelopment  
Section 106 Evaluation – CDBG/EPA

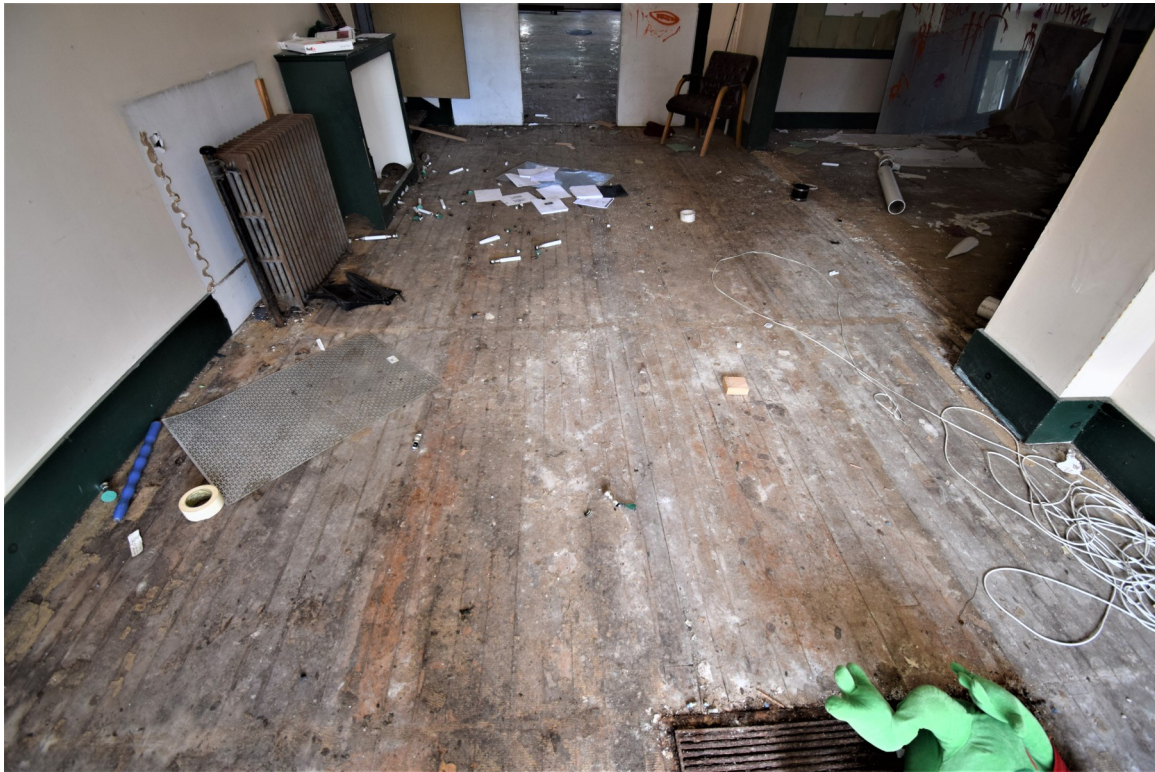
Photo 05: Looking west in room 1-1, view shows extant hardwood strip floor

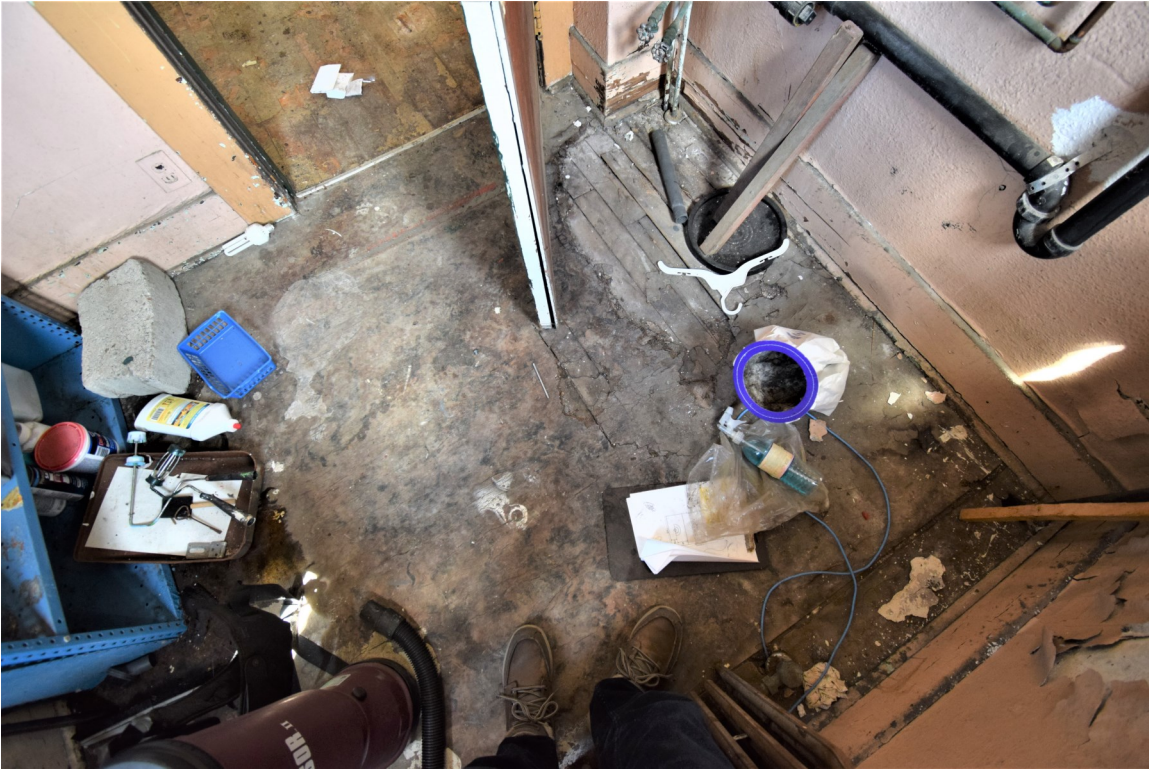
Other than bathrooms, floors are hardwood strip throughout the front block interior though it has been removed fully or partially in some rooms exposing the diagonal plank subfloor. Remaining hardwood has been damaged by water leaks and is decayed and/or buckling. Significant water damage is evident throughout the main block. Walls and ceilings are plaster and lath in a range of conditions – from fair to failed conditions where sections of plaster are collapsing or have been removed. The exception is the first-floor center hall 1-1 which is mostly sheetrock dating to the 1970s when the building was converted for use as the Town recreation center. Trim is uniformly flat stock boards throughout, including baseboards, window casings, and door casings. Some plain board chair rails are in place. Note the window casings have projecting bullnosed sills over the lower casings. Windows to the exterior are uniformly 1/1 single strength, single-hung wood sash with rope and pulley hardware – intact on most windows. Conditions of the windows vary, with areas of decay on the lower sash where they have been exposed to moisture from rain, and from snow accumulating on the concrete window sills.

Photo 09: Looking west in room 1-4, view shows general floor conditions

Per the building description, front block wood flooring is either missing or deteriorated beyond reasonable means of refinishing. What hardwood that does remain will be removed to access the floor framing. The center halls on the first and second floors will be recovered in hardwood strip floors per the original. The bathrooms and kitchen areas will be tiled or covered in sheet linoleum. Mechanical rooms and processing areas will be smooth concrete. The fitness room will have a rubberized floor. The rest of the floors will be sheathed in Advantech or equivalent flooring and covered with commercial grade tile carpet.

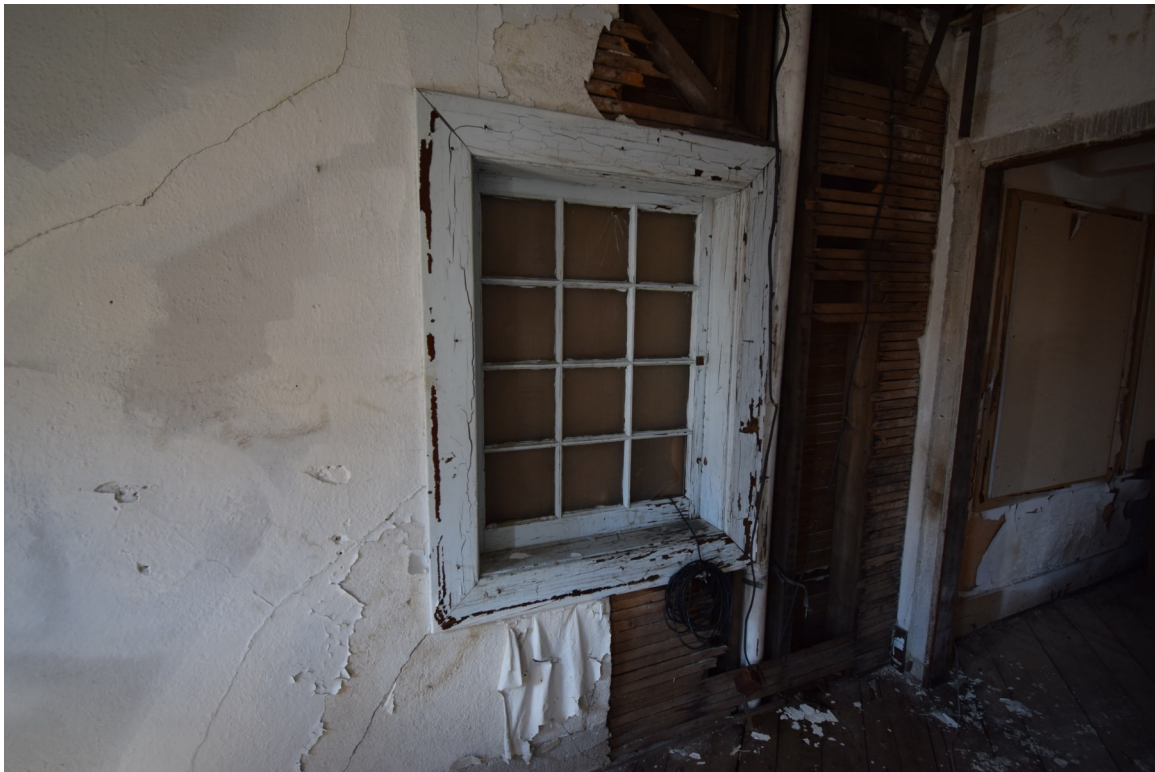
Photo 57: Looking west in room 2-6, view shows extant window into the drill hall, blocked on the drill hall side

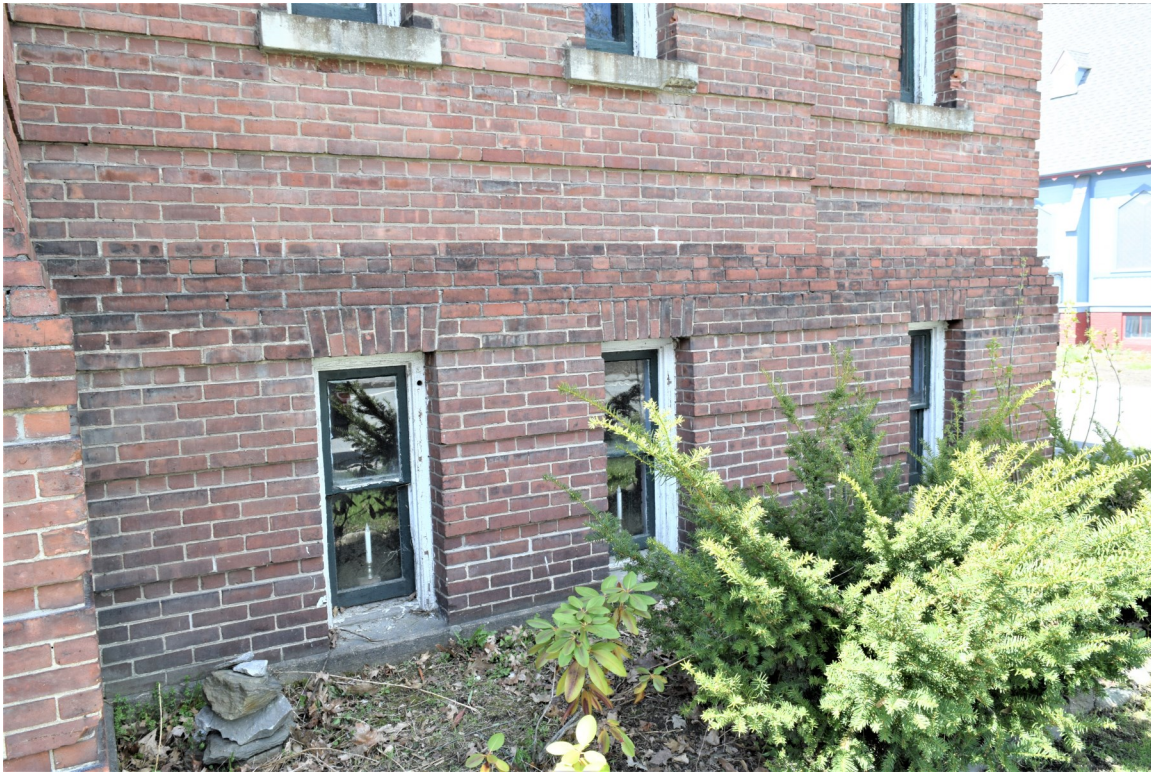
Photo 29: Looking northwest, view shows projecting basement level and exposed concrete foundation

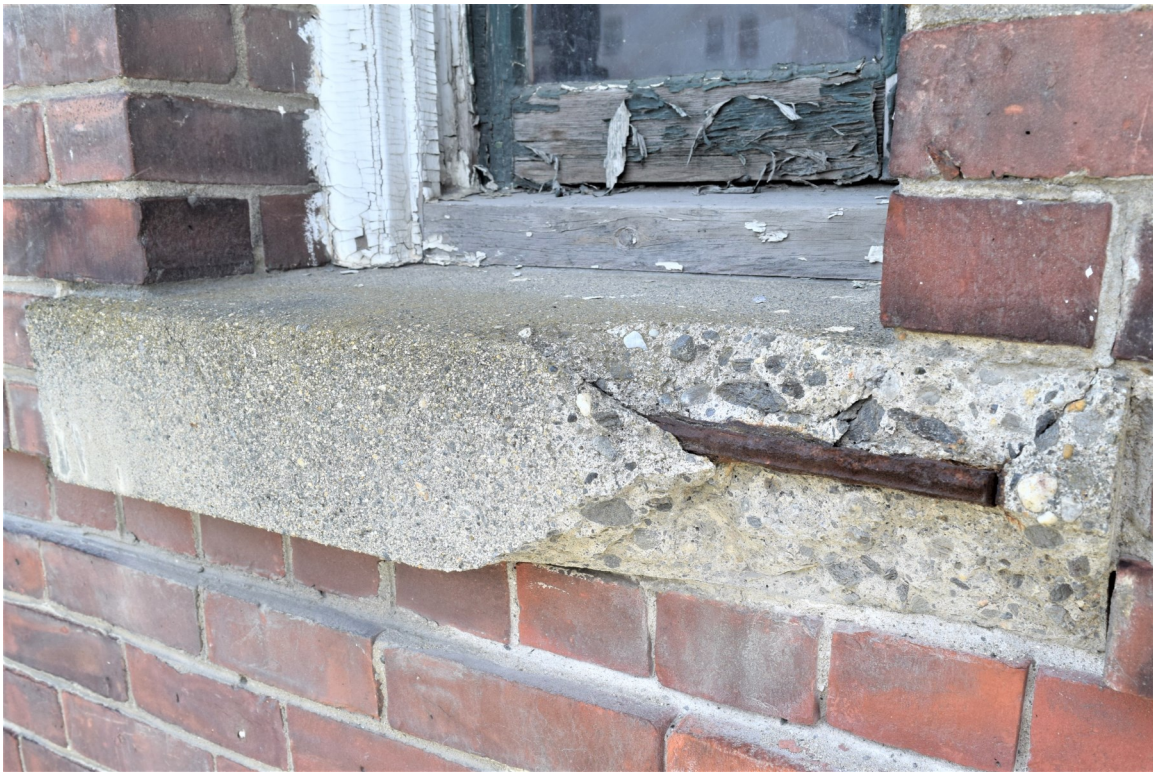
Existing windows are described in the building description section, being a uniform 1/1 wood sash design except where they have been removed in some basement openings with only the storm windows remaining in place. Conditions of the windows are fair, with most of the lower sash showing varying levels of water related decay. Three of the windows, those directly above the front door will be repaired and retained as examples of the original materials and design including exterior and interior casings. Remaining windows will be replaced with full frame replacements to ensure glass area on the existing narrow windows is maintained. New windows will be single hung, aluminum clad wood units to match the geometry of the existing windows. All jackarches and concrete sills will be retained and repaired as required. Exterior brick molds will be replaced with custom run moldings to match the existing. Because the exterior walls are being thickened on the inside by approximately 4", jamb extensions will be installed for the three historic façade windows being preserved. Windows in new openings on the rear block will be fitted with plain granite lintels and sills to differentiate them as new.

Photo 38: View shows main block window with deteriorated lintel and water related decay on lower sash

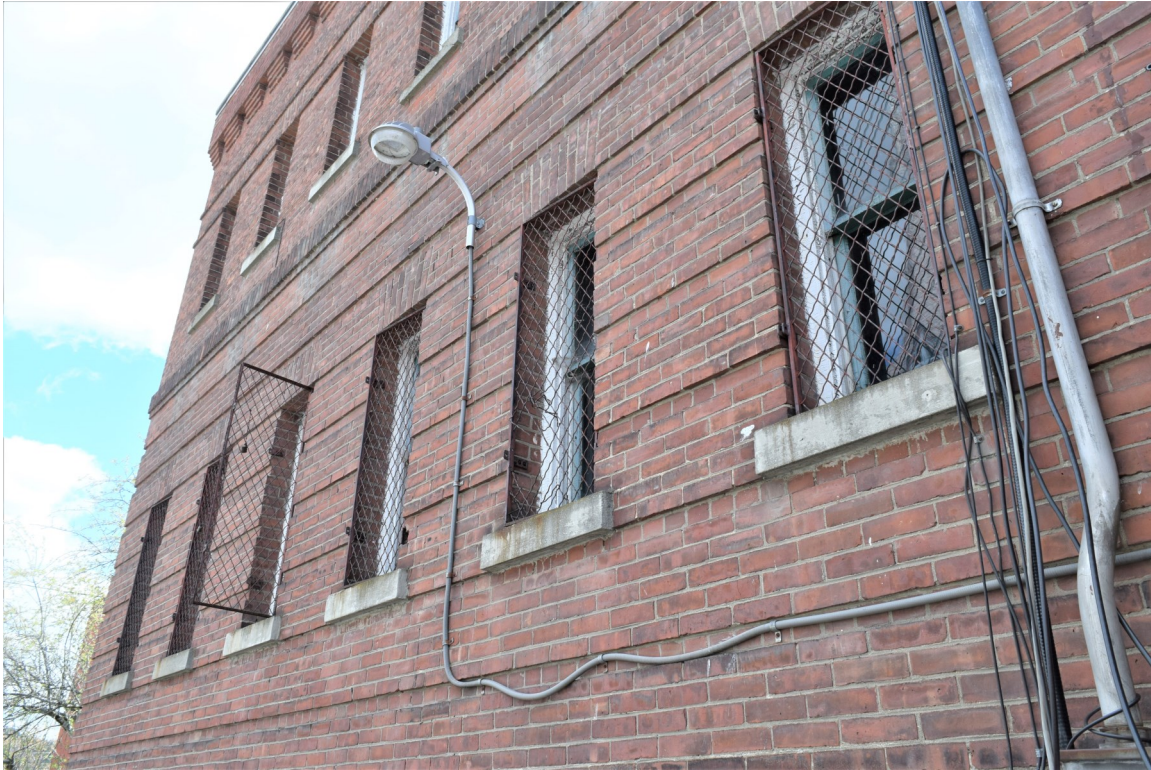
Photo 39: Looking southeast, view shows main block north elevation first floor sash protected by metal security grates
