ADDENDUM NUMBER 1 TO THE REQUEST FOR PROPOSAL (RFP)

Relocation of Building Debris / Asbestos Containing Materials
Associated with Structurally Compromised Buildings
Former True Temper Site (SMS #2024-5394)
575 Concord Avenue, Saint Johnsbury, Vermont
ISSUE DATE: February 20, 2025
BID DEADLINE: March 19, 2025 at 5:00 pm

Re: Inspection for Asbestos Containing Materials
Former True Temper Facility, 575 Concord Avenue, St. Johnsbury, Vermont
CPAI Project #16152

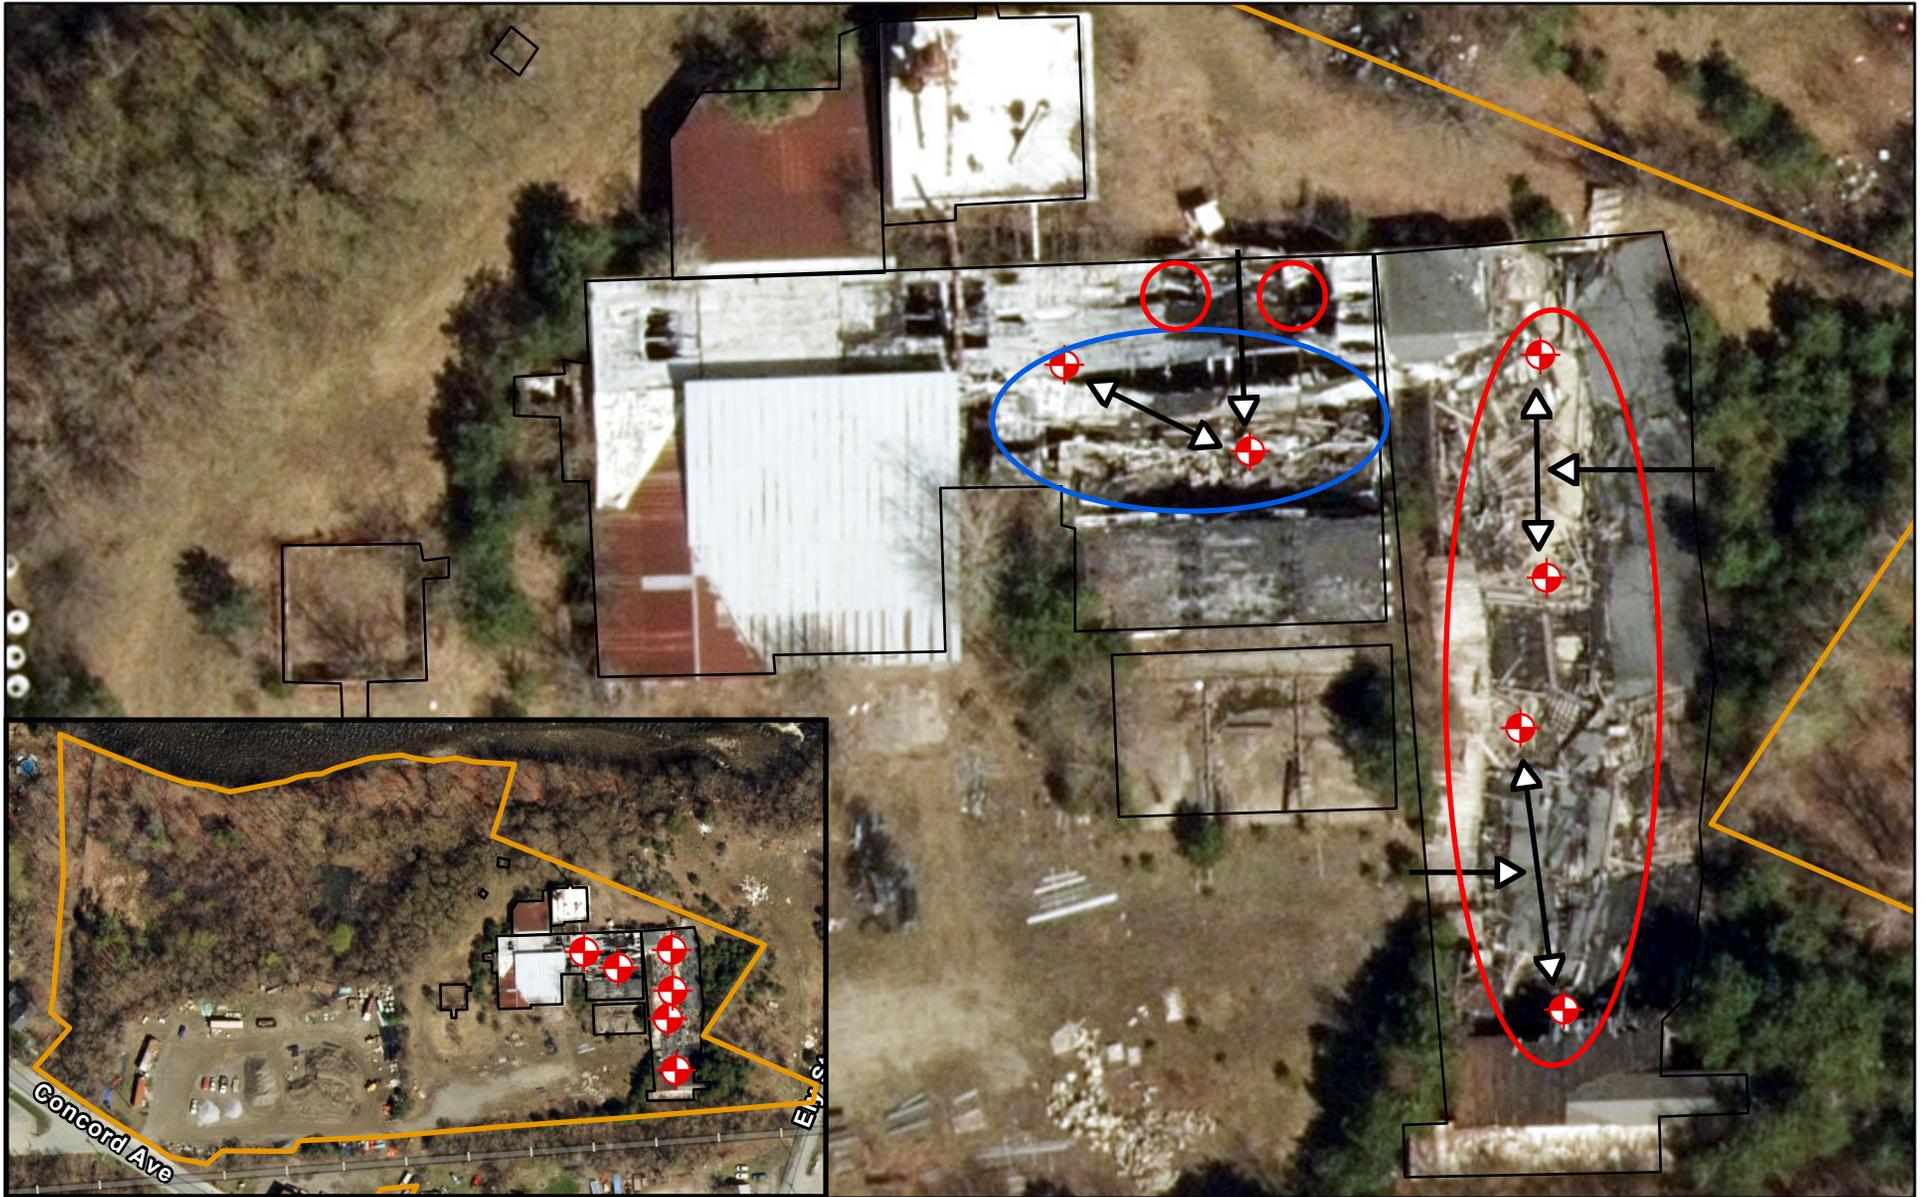
CREATION DATE: MARCH 13, 2025	PROJECT NO: 224534	FIGURE 1 SITE PLAN AND DRILLING LOCATIONS

In the first sentence, delete the phrase, "eight (8) unique locations" and replace it with the phrase, "up to six (6) unique locations". See revised **Figure 1** (attached).

Add the following sentences to item 2, “The Base Scope shall be completed by the Contractor at the direction of Montrose to clear / relocate the eastern four (4) locations and to clear vegetation / debris at two locations to 10 feet within the building footprint (i.e. excavator is positioned outside of building) to allow for inspection of flooring material within the general area of the two (2) central locations. Montrose or CPAI shall conduct the inspection of flooring material. If a concrete slab is not found or compromised flooring is observed indicating the area is over a basement, the Optional Scope will not be initiated. If a concrete slab is observed, the Optional Scope shall be conducted by the Contractor at the direction of Montrose. The concrete slab shall be completely cored (2-inch minimal diameter) for inspection by Montrose or CPAI to observe the potential presence of a basement. If no basement is observed, the Optional Scope Area will be cleared for access by a drill rig as detailed above.”

The Contractor shall meticulously relocate building materials/debris to create a clear path, approximately twelve (12) feet wide, for a drill rig to access the designated drill point.

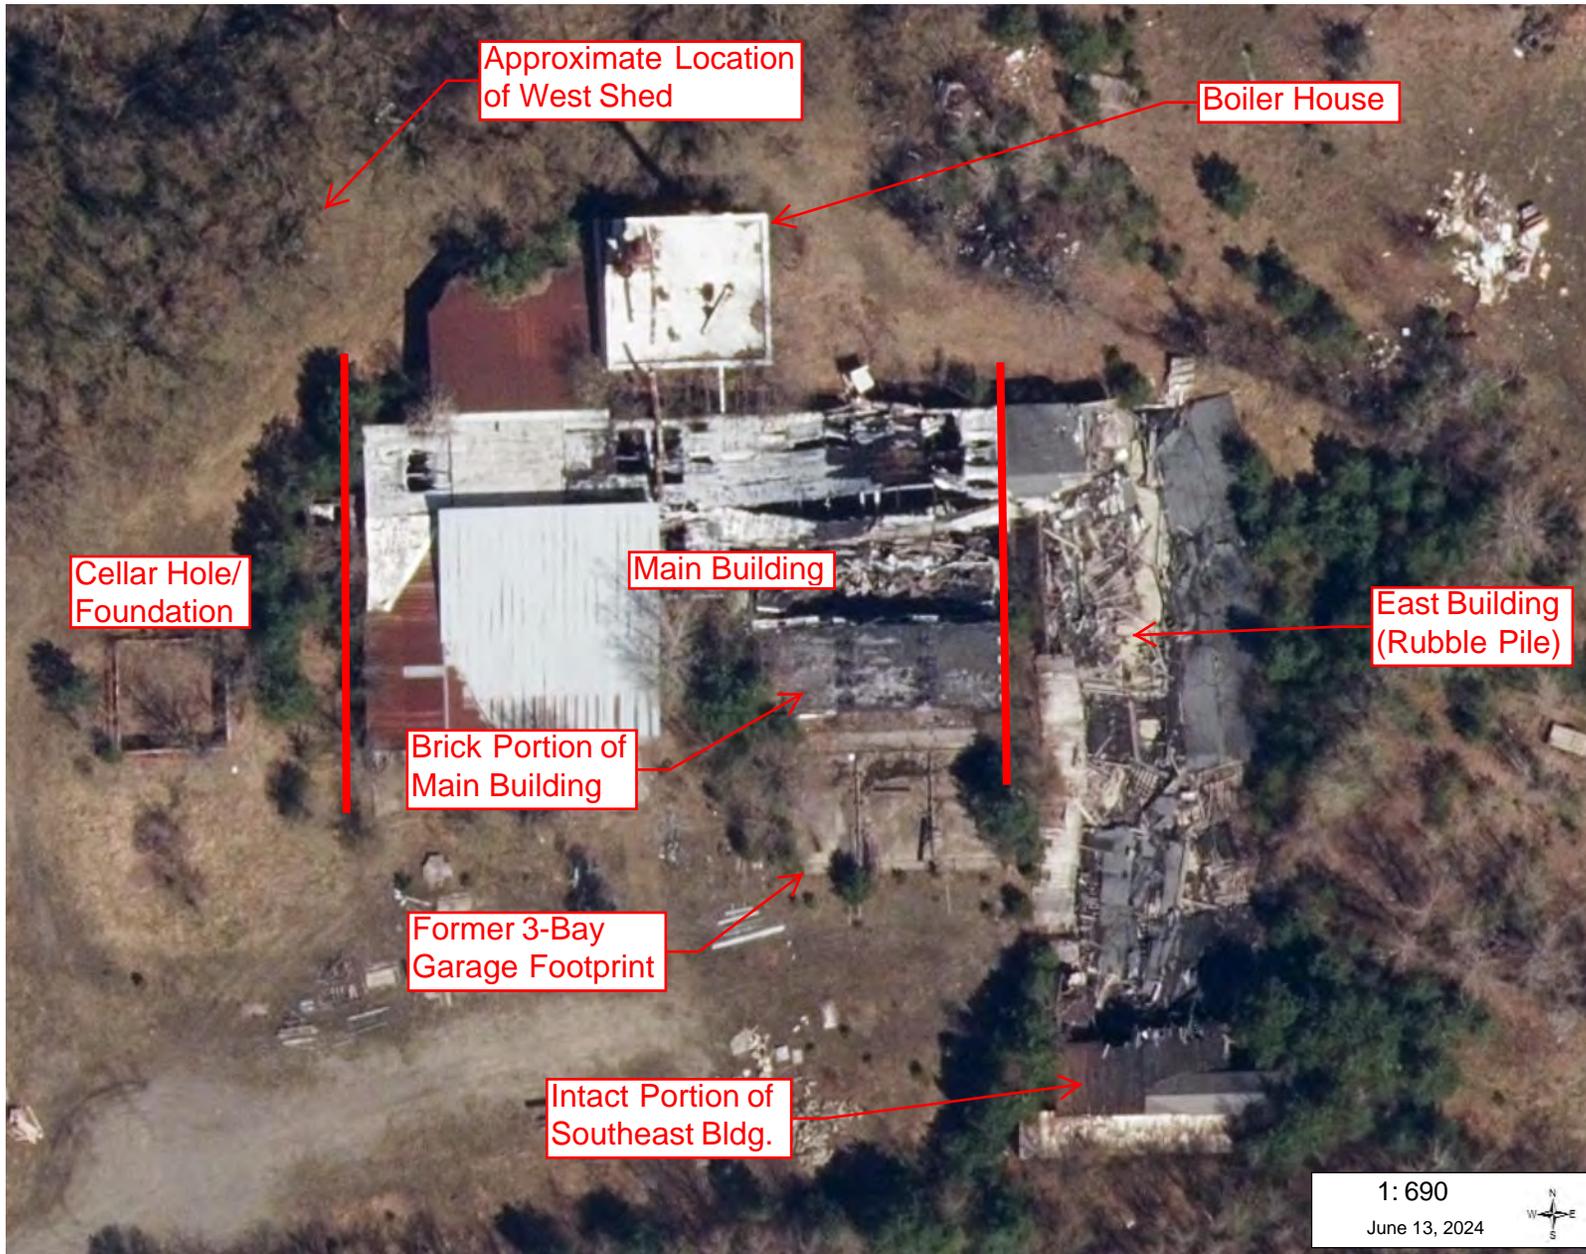
Asbestos Inspection
Not to Scale
Drawn By: Christer Herrmans

Industrial Structure
575 Concord Avenue
St. Johnsbury, Vermont

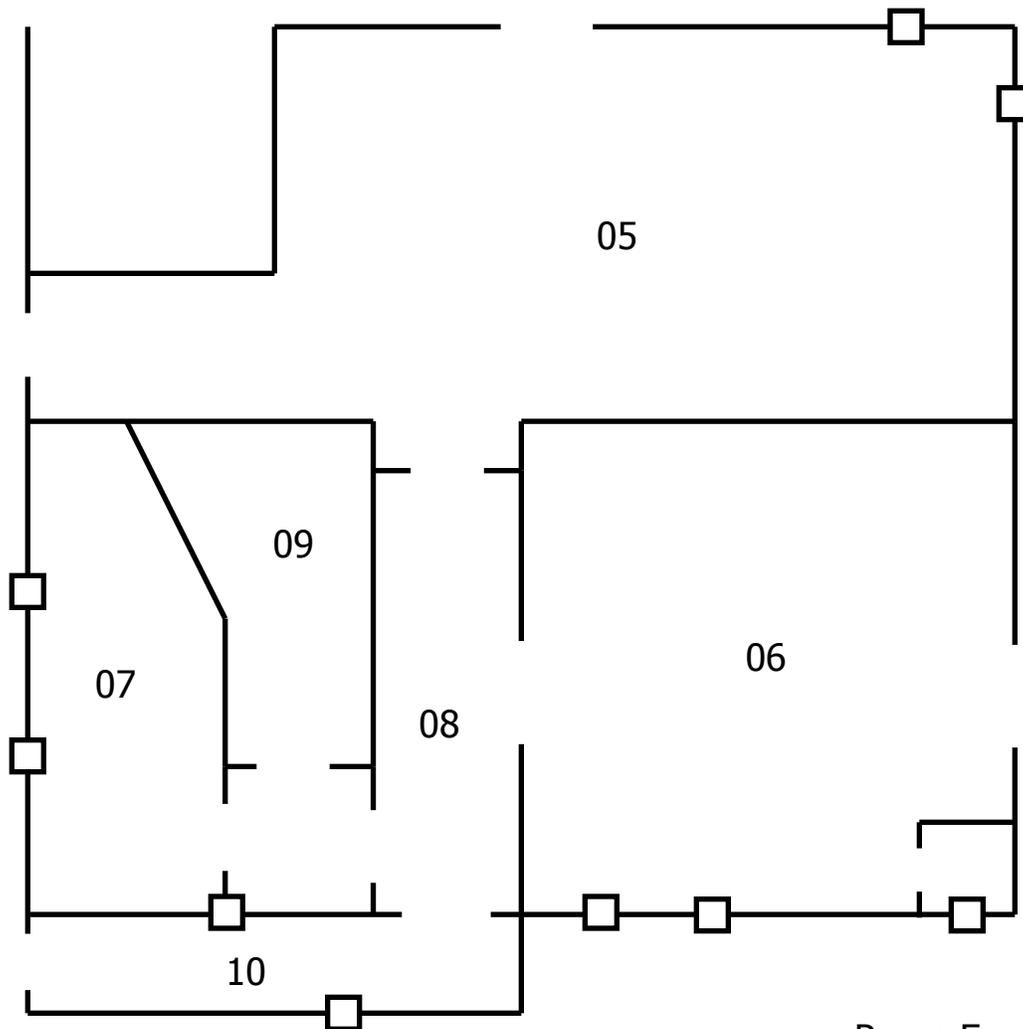
Clay Point Associates, Inc.
Project #16152
May 14, 2024

- Room Equivalent:
- 05 = Boiler Room
 - 06 = Storage
 - 07 = Bathroom
 - 08 = Hallway
 - 09 = Bathroom
 - 10 = Entry

Boiler House
575 Concord Ave.
St. Johnsbury, Vermont

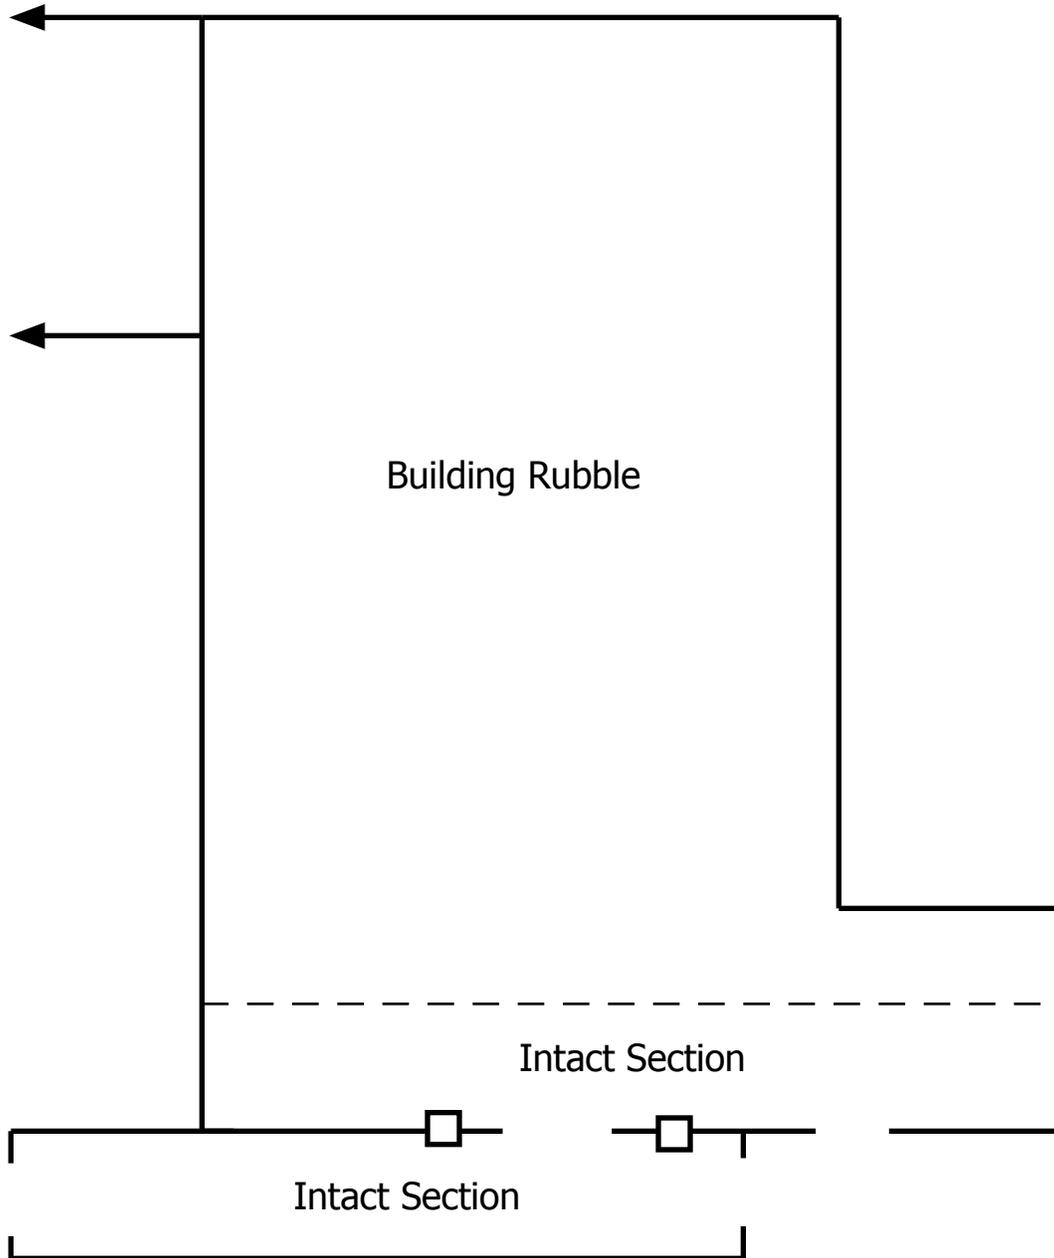
Clay Point Associates, Inc.
Project #16152
May 14, 2024

East Building
575 Concord Ave.
St. Johnsbury, Vermont
